## LIMITING ABNORMAL MOLD GROWTH IN BUILDINGS

Charles W. Graham, Ph.D., AIA \* Architect, Mitchell Endowed Professor  
Department of Construction Science \* Texas A&M University \* College Station, TX

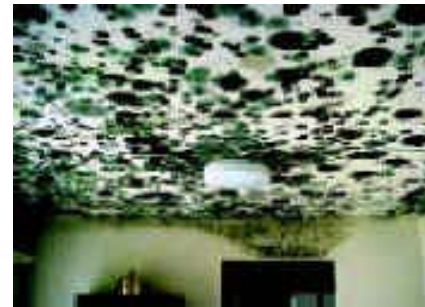
Figure 3. Extensive Mold Growth in a Building

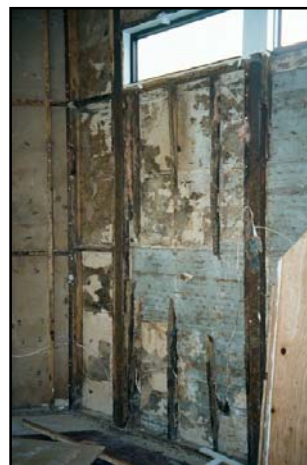
Figure 8 shows what happens when water gets past the rain screen of a surface barrier design wall cladding that does not have a drainage plane or moisture barrier behind it. In this case, a surface barrier EIFS was installed on the building. Water that got behind the insulation boards was absorbed in the gypsum board wall sheathing. Eventually the gypsum sheathing deteriorated, and the supporting wood framing rotted as shown. Obviously, this level of decay greatly reduces the structural capacity of a building.

Figure 8. Example of Extensive Decay of Wood Framing

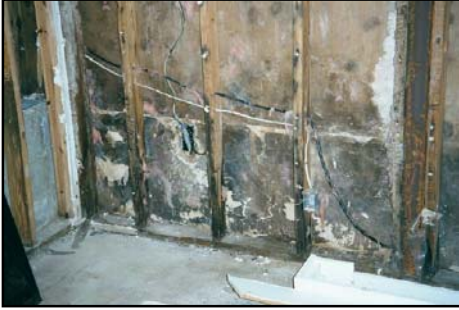
Figure 9. Mold Growth in the Interstitial Cavity of a Wall
